Manildra Solar Farm Construction – Environmental Representative (ER) Inspection Report

Date of Inspection	13/09/2017	Location of Inspection	Manildra Solar Farm
ER	Demelza Scott	Proponent Representative	Bjorn Schultz Aaron Hawkins
Weather	Fine and partly overcast	Construction Contractor Representative	Baz Tuppin
Follow up from previous inspection	<p>Corrective Actions:</p> <p>CA 170810 - 01: Maintain spill kits in areas that are readily accessible in the event of a spill. <i>Sighted spill kit in main RCR site compound and on refuelling trailer.</i></p> <p>CA 170810 - 02: Manage trenches in accordance with Protocol 4: Trenching to minimise trap hazard for fauna. <i>RCR SCECO reported that the trench was dewatered immediately and covered with pallets to prevent fauna being trapped.</i></p>		
Inspection Summary	Improvement Opportunity – 0	Corrective Action – 1	
	<p>Open Corrective Actions:</p> <p>CA 130917 – 01: Conduct appropriate checks and inductions on subcontractors, their staff and plant/equipment prior to conducting any work on the project.</p> <p>Appendix A Corrective Action Register to track identification and close out of corrective actions.</p>

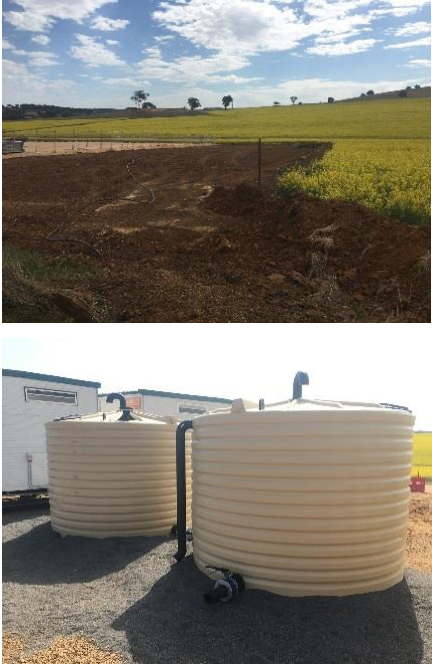
Issue	Observations & Corrective Actions	Due Date	Photographic Record
	<p>The on-site sewage treatment system has been installed and connected. The trench has been filled. The irrigation area (pictured) has been seeded and erosion and sediment controls were in place.</p> <p>Rainwater tanks have been installed including connection for Rural Fire Service, if required.</p>

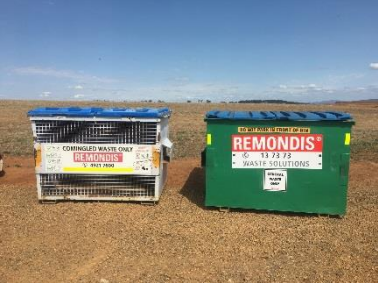
Issue	Observations & Corrective Actions	Due Date	Photographic Record
Waste	<p>RCR have engaged Remondis for waste management and transport for the project. Two waste skips have been provided for co-mingled recyclables and general waste.</p> <p>Remondis were on-site conducting the project's first waste collection at time of the inspection. RCR are yet to induct the driver and review Remondis' plant and equipment to determine if it satisfies RCR's acceptance requirements for general mobile plant.</p> <p>Other waste materials e.g. wooden pallets have been stockpiled in the laydown area for potential reuse or later recycling/disposal.</p> <p>Corrective Action 130917 – 01: Conduct appropriate checks and inductions on subcontractors, their staff and plant/equipment prior to conducting any work on the project.</p>	N/A

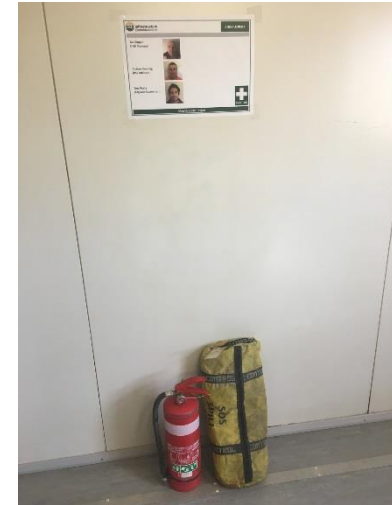
Spill kits were available observed in the RCR site compound and on the refuelling trailer.

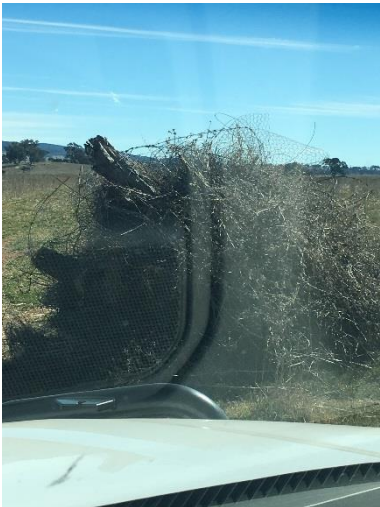
Issue	Observations & Corrective Actions	Due Date	Photographic Record
Waste	<p>Minimal waste has been generated at site to date. General solid waste from crib room is taken to Manildra Waste Facility twice weekly.</p> <p>Waste receptacles for segregation of construction waste have not been set up on site. Sighted Contractor's Weekly Environmental Site Inspection Checklist that included an improvement opportunity to order waste bins and have them in place prior to commencement of the construction program.</p>		
	<p>Spoil and topsoil observed to be stockpiled separately.</p>		
	<p>Old farm fencing has been removed from the majority of the development envelope. Temporary stockpiles of timber fence posts and wire are located across the site.</p> <p>Old fencing to be transported to MWF for recycling.</p>

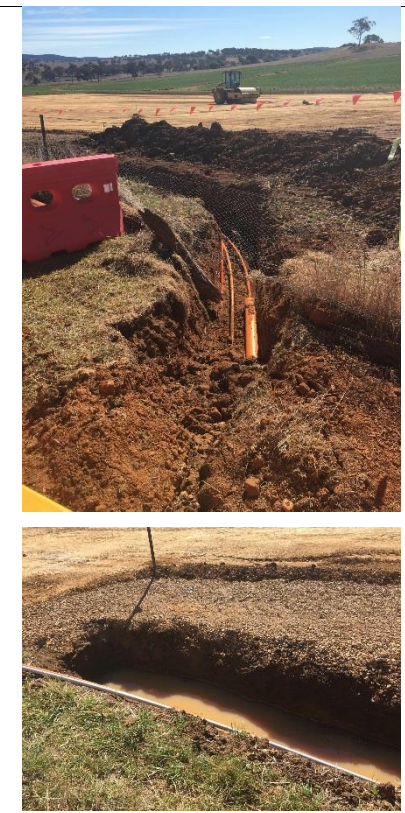
Issue	Observations & Corrective Actions	Due Date	Photographic Record
Flora and Fauna	<p>A trench under the main access road for services and effluent reuse has been open for two days. Protocol 4: Trenching from the Flora and Fauna Management Plan (FFMP) had not been implemented.</p> <p>Water truck operating on the adjacent main access road had filled the trench with water.</p> <p>Corrective Action 170810 - 02: Manage trenches in accordance with Protocol 4: Trenching to minimise trap hazard for fauna.</p>	<p>Advised at time of audit to correct immediately.</p> <p>17/08/2017</p>

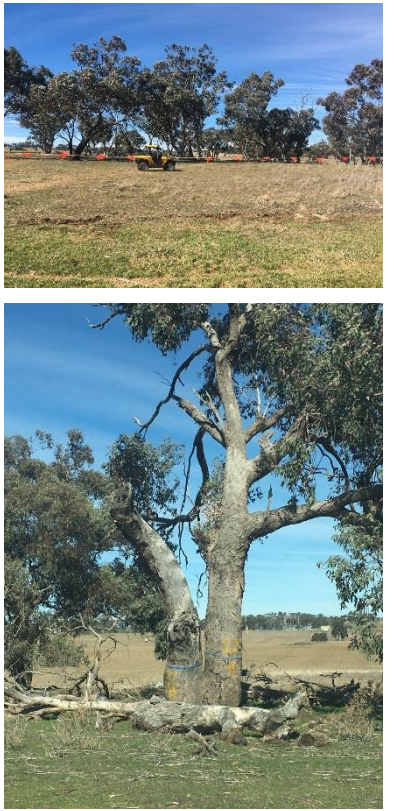
Issue	Observations & Corrective Actions	Due Date	Photographic Record
	<p data-bbox="443 411 1335 539">Ecologist (Geolyse) on site at time of ER inspection conducting pre-clearing surveys and identification of trees to be retained and those to be removed. Stands of remnant vegetation to be retained have been flagged as 'no go zones'.</p> <p data-bbox="443 555 1055 587">Clearing to be conducted no earlier than 21 August.</p>

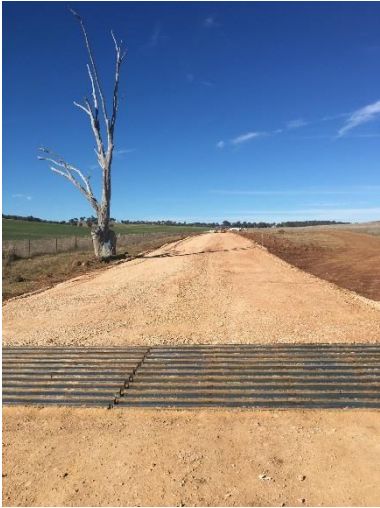
Issue	Observations & Corrective Actions	Due Date	Photographic Record
Traffic	<p>Main access road and site compound were under construction at the time of the inspection.</p> <p>A grader, roller and water truck were operating. Trucks were delivering road construction materials at the time of ER inspection.</p>

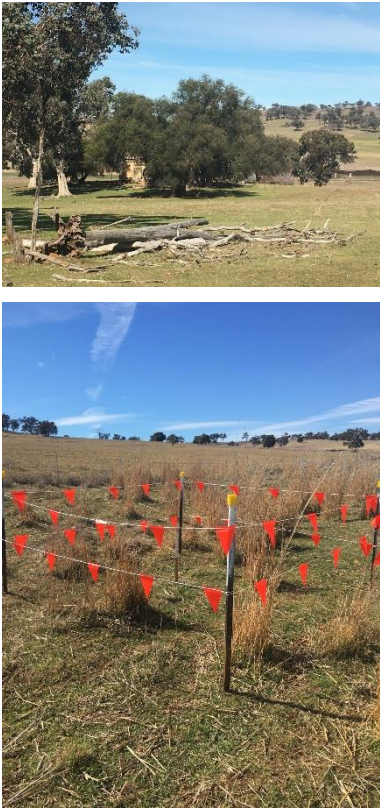
Issue	Observations & Corrective Actions	Due Date	Photographic Record
	<p data-bbox="443 411 1335 475">Sites of potential Aboriginal scatter and stone ruin were identified on site by flagging and signage.</p> <p data-bbox="443 491 1335 616">Archaeologist (NSW Archaeology) confirmed that the scatter is of low significance and does not require any specific management protocols. RCR have committed to protecting the scatter and on completion of perimeter fencing, it will be outside of the construction footprint.</p>

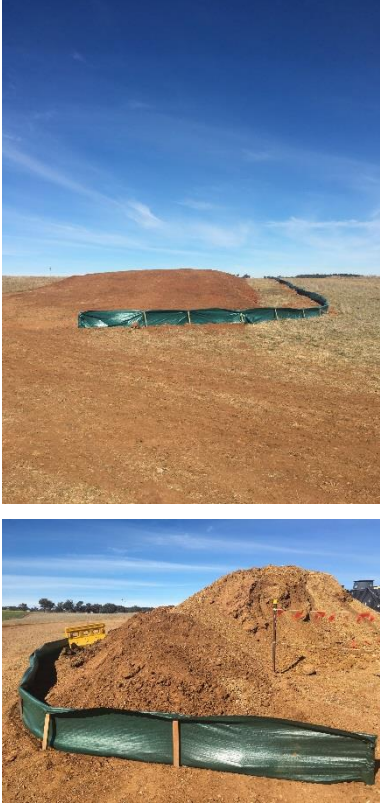
Issue	Observations & Corrective Actions	Due Date	Photographic Record
Soil and Water	<p>Two stockpiles were constructed at the time of ER inspection.</p> <p>Aerated Wastewater Treatment System (AWTS) was in the process of being installed. Temporary stockpile of spoil was protected by a sediment fence on the downslope side.</p> <p>Topsoil stockpile was located behind the temporary site compounds and car park. It was protected by a sediment fence on the downslope side.</p>

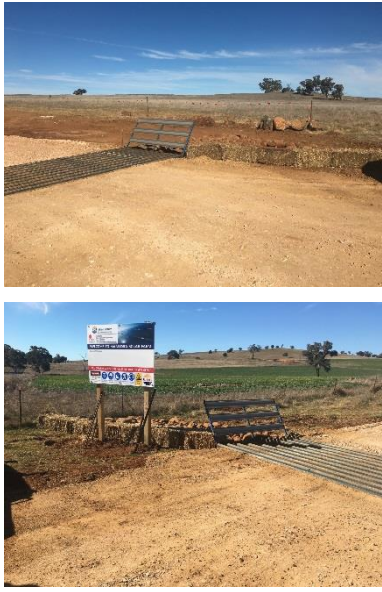
<p>Stabilised entry consisted of a rumble grid, hay bales reinforced with large rocks.</p>

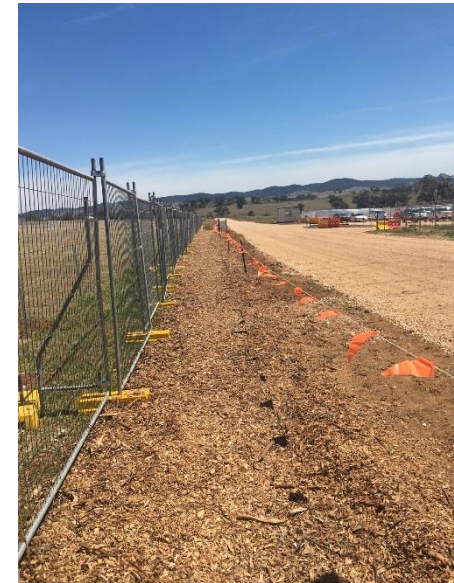
The main access road appears to be in good condition and handling the movement of heavy vehicles for delivery of plant and materials to site.

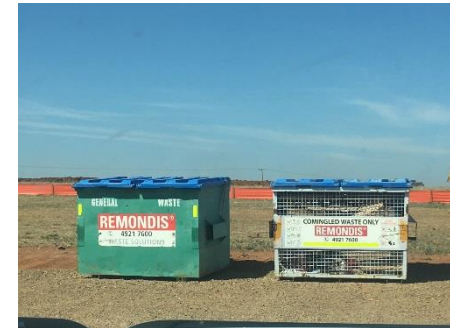
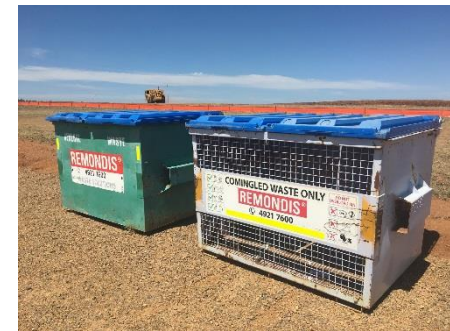
Waste and recycling bins were observed on site and waste was observed to be segregated. RCR have not received a waste docket for the first removal yet. RCR have not inducted the waste collection driver and he attended site on the day of the inspection and did another waste collection.

Refer to CA 130917.

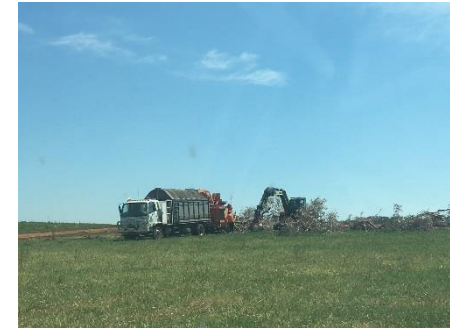
To date, rocky outcrops have been left insitu where they are not in the vicinity of trees to be removed. The FFMP Protocol 2 requires that rocky outcrops within the development envelope are fenced with a 2.5m buffer, wherever possible. This was not observed to be occurring on site.

FFMP states that, where security considerations permit, perimeter fencing will not contain barbed wire, particularly the top strands. Perimeter fencing was observed to be constructed with three top strands of barbed wire.

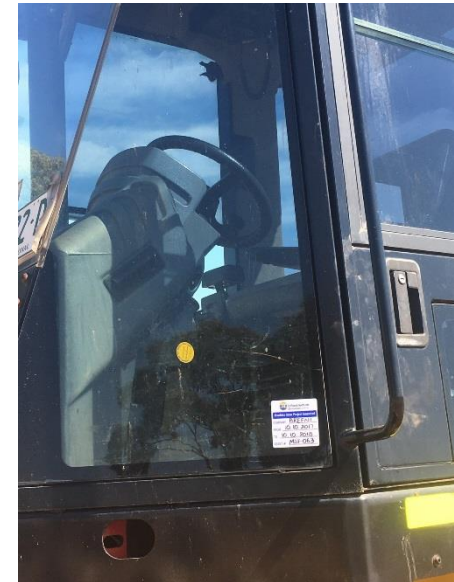
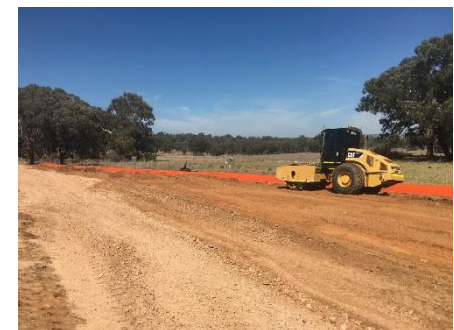
Plant and vehicle drivers were observed to be actively using the UHF network to communicate traffic movements around site.

Sighted Council Works Permit for activity on a public road (Packham Drive BAR construction) and RCR plant acceptance documentation for Pad Foot Roller that was working on Packham Drive.

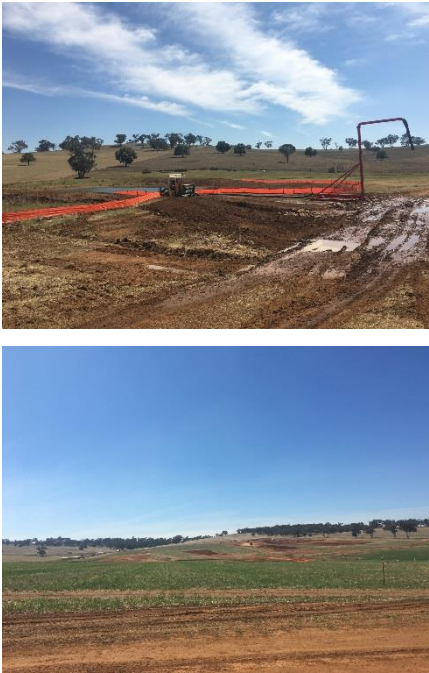
Issue	Observations & Corrective Actions	Due Date	Photographic Record
Soil and Water	<p>RCR have cleaned out the former farm dam, and formed and seeded the batters. The dam receives water from catchment runoff and a supply from the landholder. Sediment fencing has been installed upslope and downslope of the dam as an erosion and sediment control measure and encourage access at the designated point. A pump and standpipe have been commissioned this week for filling site water trucks. RCR had laid rock at the fill point however it has not been sufficient to prevent muddying of the access way. RCR have identified this as an issue in their Weekly Environmental Inspection and plan to lay additional rock to stabilise the area.</p> <p>The site received 16mm in 36hrs over the weekend. Although this did not trigger a wet weather inspection as per the CEMP, RCR conducted a Wet Weather Inspection to check the effectiveness of erosion and sediment controls.</p>

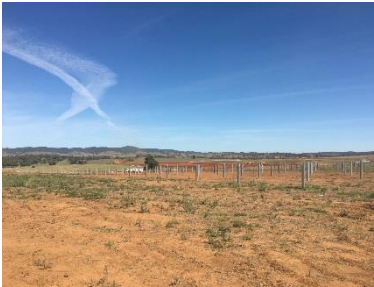
Issue	Observations & Corrective Actions	Due Date	Photographic Record
Dust	<p>As during previous inspections, water trucks were operating on site. Generation of dust was not observed to be an issue despite the number of vehicles operating across the site and the significant area of disturbed land.</p>

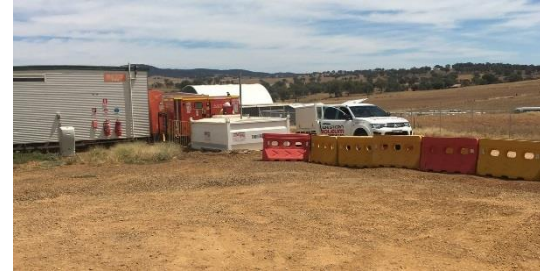
Issue	Observations & Corrective Actions	Due Date	Photographic Record
<i>Chemicals and Fuels</i>	A representative from Western Petroleum was observed on site inspecting the bulk diesel refuelling station.

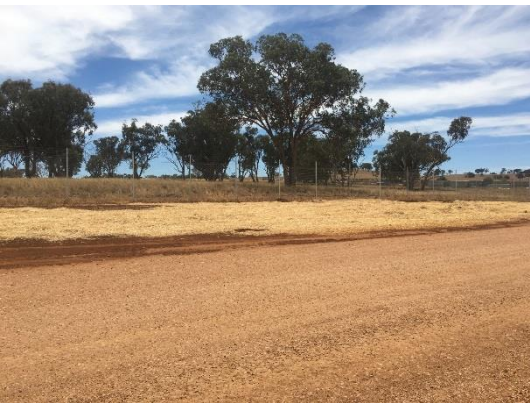
Issue	Observations & Corrective Actions	Due Date	Photographic Record
	<p>standpipe and farm dam be removed so as not to impede natural water flow.</p> <p>Topsoil spreading was underway during the inspection and was generating localised dust. RCR could consider options for pre-treating topsoil with a binding agent prior to spreading and establishing procedures that prohibit spreading of topsoil where wind conditions would exacerbate dust generation.</p> <p>Drilling, pile driving and traffic movements on site roads were all observed to be generating localised dust. RCR advised that two water trucks were still maintained however these were not observed to be operating during the inspection. No dust was not observed to be travelling over site boundaries or impacting on neighbours and no dust complaints have been received, however the CoA requires that there are no visible dust emissions from the project.</p> <p>Corrective Action 210218-02 – Implement all practicable dust mitigation measures to cease emission of visible dust generated by the project.</p> <p>Corrective Action 210218-03 – Place additional rock to stabilise the internal road on the north-east perimeter from water flowing onto site.</p> <p>Corrective Action 210218-04 – On completion of construction, remove the access road from the array to the farm dam so as not to impede natural water flow.</p>

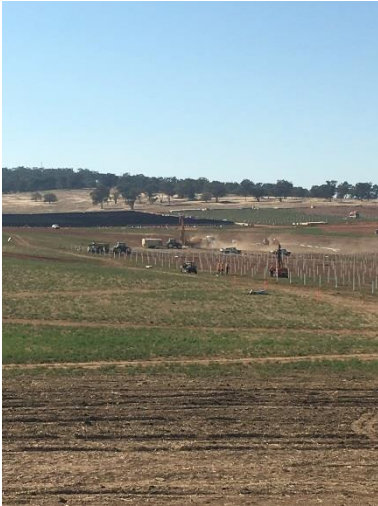
Issue	Observations & Corrective Actions	Due Date	Photographic Record
<i>Dust</i>	<p>Localised generation of dust associated with vehicle movements on site roads and drill rig operation was observed.</p> <p>One water truck was operating on site during the inspection. Two water trucks were previously operating on site. The addition of a second truck would allow for wetting down of earthworks activities as well as the internal road network to further reduce dust generation.</p>

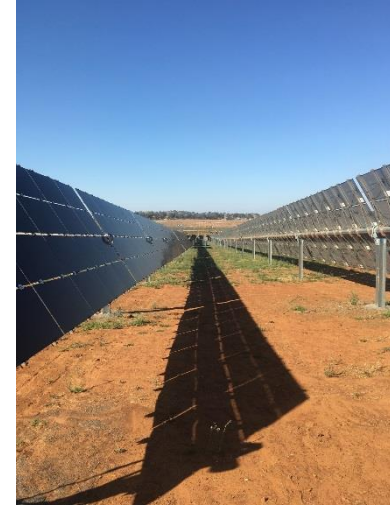
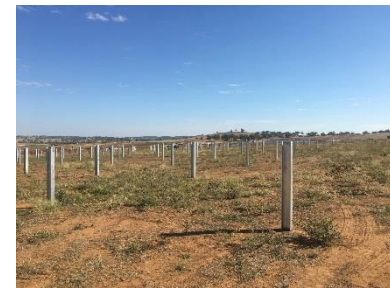
RCR advised that nest boxes are due to arrive on site the week of 19 March.
Trenching is almost complete.
Good regrowth was observed across the site.

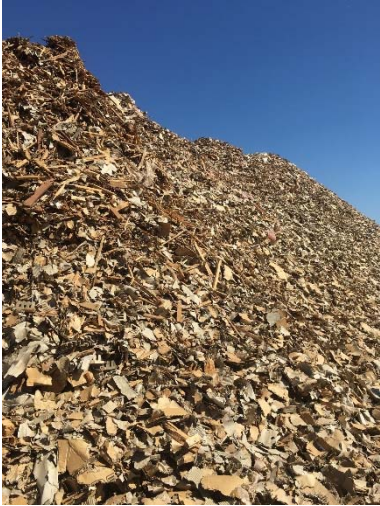
Issue	Observations & Corrective Actions	Due Date	Photographic Record
<i>Dust</i>	<p>RCR advised that dust hasn't been an issue despite the dry conditions. Bulk earthworks are complete and with the demobilisation of the earthmoving contractors the traffic movements around site have reduced.</p> <p>Some dust was observed during the site inspection associated with vehicle movements and drilling/pile driving. This dust was localised in nature and not causing any harm or nuisance to neighbouring properties.</p>		
<i>Waste</i>	<p>RCR advised that the mulching contractor is to be mobilised three times to progressively mulch the cardboard and NEXTracker waste. RCR advised that negotiations with Cabonne Council to take the NEXTracker waste are ongoing. RCR are proposing to use the mulched cardboard to construct a mulch berm on the south-western boundary in accordance with the Soil and Water Management Plan (SWMP). RCR advised that it would be covered with jute matting to prevent windblown rubbish onto neighbouring properties.</p> <p>The mulch stockpiles were inspected. As previously reported, First Solar had stipulated specifications for mulched material including removal of nails and other extraneous materials and sizing of the final mulched product. The mulch pieces were observed to be very large and there were significant amounts of plastic wrap and other extraneous materials in the final product. The ER is concerned that the use of this mulched product to construct a mulch berm would result in an ongoing source of litter from the development as the jute matting breaks down.</p> <p>On review of the SWMP, there is no timing specified for construction of the mulch berm. Given that the SWMP states that the mulch berm was intended to prevent sediment movement offsite, it should have been installed prior to commencement of bulk earthworks and would provide little additional protection if installed on completion of construction.</p> <p><i>Corrective Action 110418-01 – Implement stricter quality control on mulching of cardboard including smaller sizing, removal of plastic, nails and staples.</i></p>	4/05/2018

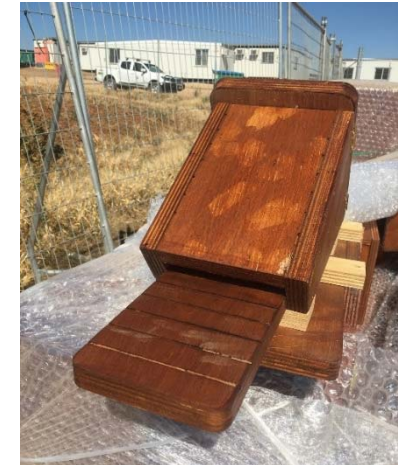
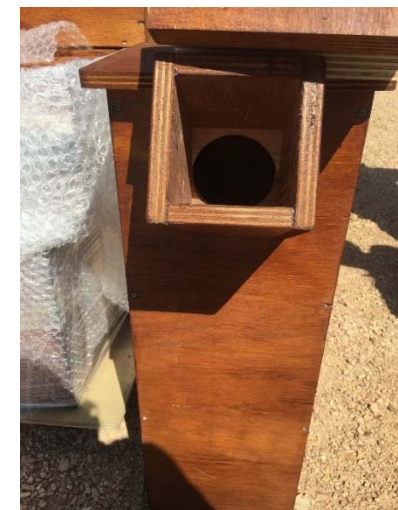
Nest boxes have been delivered but were yet to be erected at the time of the inspection.

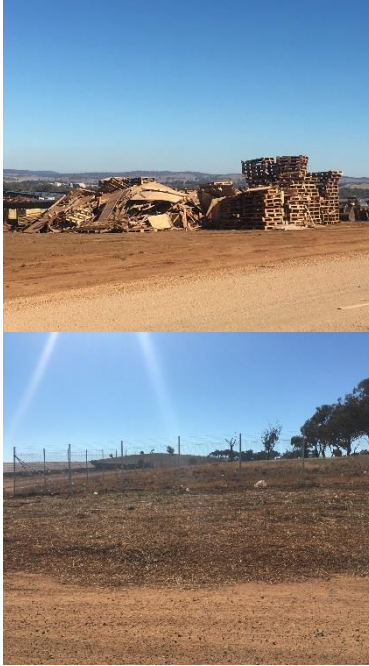
Issue	Observations & Corrective Actions	Due Date	Photographic Record
Waste	<p>Wind-blown litter from the mulched cardboard and pallets was an issue on site and on the neighbour's property. Waste packaging was also observed scattered across site, yet to be picked up.</p> <p>First Solar and RCR advised that mulched cardboard and pallets will not be used in a mulch berm as previously discussed. Discussions are underway for the mulched material to be taken to Molong waste management facility where it will be mixed with general household waste to aid in compaction of waste. First Solar and RCR are in discussions with VISY regarding accepting the module boxes for recycling.</p> <p><i>Corrective Action 230518-01: RCR to manage wind-blown litter on site and on neighbouring properties including covering the mulch stockpiles with netting.</i></p>

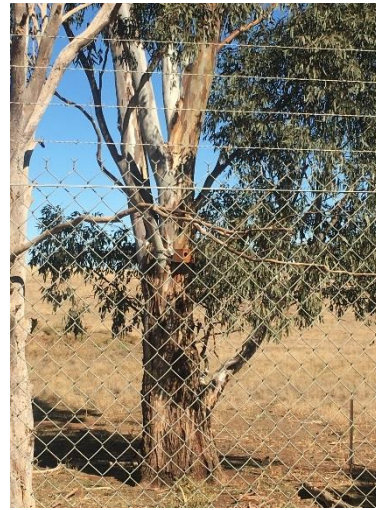
Issue	Observations & Corrective Actions	Due Date	Photographic Record
Flora and Fauna	<p>Nest box installation was well underway, with 50 out of the 60 proposed nest boxes installed. The remaining 10 were planned to be installed later in the week. A map is to be created showing the location of nest boxes.</p> <p>First Solar is still reviewing the proposal from RCR to amend the proposed screen planting plan to allow for roadside planting. First Solar have requested that the consultant who prepared the original visual impact assessment review the revised plan for consistency with the EA and Project Approval.</p> <p>Weeds are appearing to establish themselves across site. RCR advised that they are waiting until the majority of personnel have demobilised from site before commencing weed spraying.</p> <p><i>Improvement Opportunity 230518-02: RCR to commence weed spraying for listed priority weeds once personnel numbers have reduced on site.</i></p>

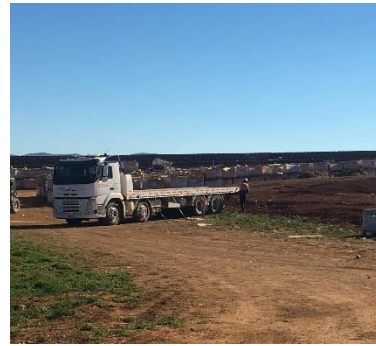
Traffic	<p>As the site is being demobilised, there has been an increase in heavy vehicle movements in removing demountable infrastructure such as crib rooms, construction sheds etc.</p>

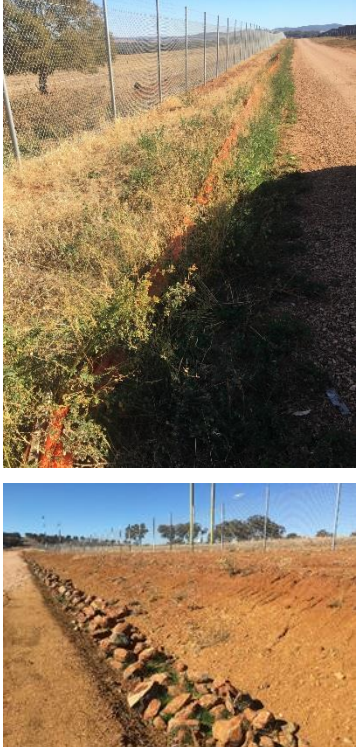
Issue	Observations & Corrective Actions	Due Date	Photographic Record
Soil and Water	<p>Sediment fences along the south-western boundary were dilapidated and are in need of maintenance. RCR were reluctant to reinstate the sediment fences as there is still work to be done in that area including additional gravel top up on the road and planting screening trees along the boundary fence, which would further damage the sediment fences. RCR have advised they would be inclined to install temporary controls such as straw bales in place of sediment fences following works.</p> <p>Good progress in regeneration was observed with noticeable seed strike in areas spread with topsoil and seeded. RCR have been in discussion with a local agronomist who advised that rain is forecast in July and seeding should be scheduled for then. RCR advised that 25% of the site is yet to be seeded. Some areas showed signs of compaction and will require ripping in preparation for seeding.</p> <p>The batter in the south-western part of the site near the operations and management buildings was reported as eroding a number of months ago with rill erosion evident and no regrowth on this batter. RCR advised that the contractor is to reshape the batter, spread topsoil, secure jute matting and seed. However the drawing provided by RCR did not provide sufficient information to confirm that this had been agreed with the contractor.</p> <p>Corrective Action 230518-02: RCR to install temporary sediment controls along the southern boundary that can be moved and reinstated as works are conducted in the area.</p> <p>Corrective Action 230518-03: RCR to confirm that the contractor will reshape the batter, spread topsoil and seed as well as secure jute matting or equivalent.</p>	08/06/2018

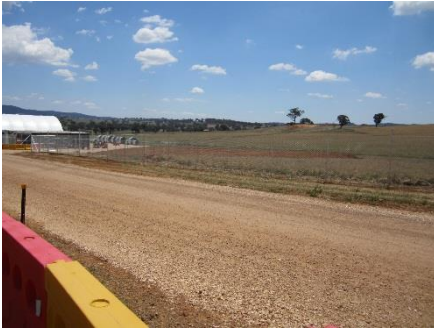
Issue	Observations & Corrective Actions	Due Date	Photographic Record
Flora and Fauna	<p>RCR advised that no rocky outcrops will remain in situ therefore CA111017 is no longer applicable. Rocky outcrops were observed to be removed in the vicinity of earthworks with rocks stockpiled.</p> <p>Topsoil stockpile has been relocated from site adjacent to main site compound, to AWTS irrigation area.</p> <p>RCR advised that nest boxes to replace hollows from trees removed on the project are still under construction.</p>

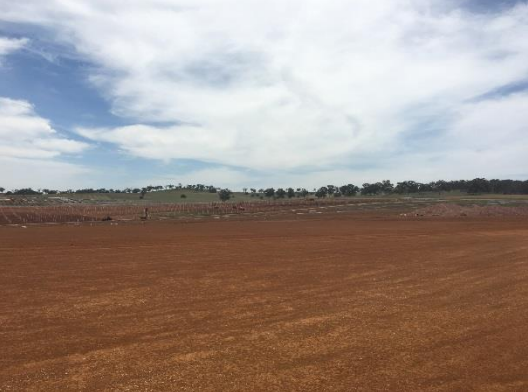
Issue	Observations & Corrective Actions	Due Date	Photographic Record
<i>Dust</i>	<p>Significant areas of cut and fill are currently exposed on the site. Construction of the main internal access roads were underway. Two water trucks were operating on site at the time of the inspection focussing on the road construction.</p> <p>Despite the hot and windy conditions, minimal dust generation was observed and it was isolated to the immediate area around the vehicle movements and rock driving.</p> <p>Regrowth of groundcover was observed below the arrays under construction.</p> <p>RCR advised a structured groundcover monitoring program is being developed and is expected to commence in February 2018.</p>
