Manildra Solar Farm Construction – Environmental Representative (ER) Inspection Report

Date of Inspection	13/09/2017	Location of Inspection	Manildra Solar Farm
ER	Demelza Scott	Proponent Representative	Bjorn Schultz Aaron Hawkins
Weather	Fine and partly overcast	Construction Contractor Representative	Baz Tuppin
Follow up from previous inspection	<p>Corrective Actions:</p> <p>CA 170810 - 01: Maintain spill kits in areas that are readily accessible in the event of a spill. <i>Sighted spill kit in main RCR site compound and on refuelling trailer.</i></p> <p>CA 170810 - 02: Manage trenches in accordance with Protocol 4: Trenching to minimise trap hazard for fauna. <i>RCR SCECO reported that the trench was dewatered immediately and covered with pallets to prevent fauna being trapped.</i></p>		
Inspection Summary	Improvement Opportunity – 0	Corrective Action – 1	
	<p>Open Corrective Actions:</p> <p>CA 130917 – 01: Conduct appropriate checks and inductions on subcontractors, their staff and plant/equipment prior to conducting any work on the project.</p> <p>Appendix A Corrective Action Register to track identification and close out of corrective actions.</p>

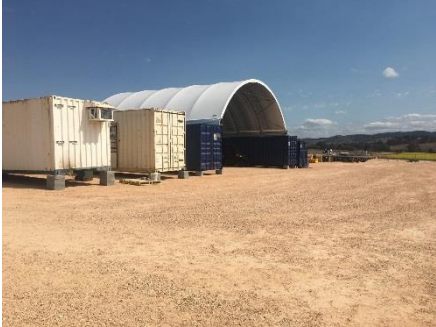
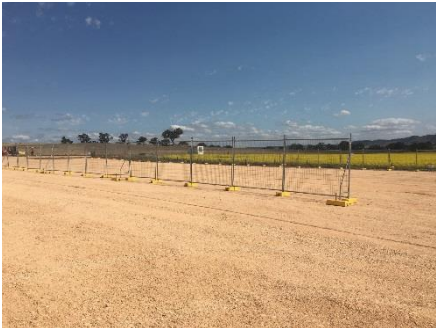
Issue	Observations & Corrective Actions	Due Date	Photographic Record
<p>Site Compound</p>	<p>Laydown area, private vehicle and bus parking, and main access road to laydown area and site compounds have been completed since the last inspection.</p> <p>On the day of the inspection, temporary barrier fencing was being installed around the laydown area, and the newly engaged civil contractor Brefni was on-site for the inception meeting.</p>

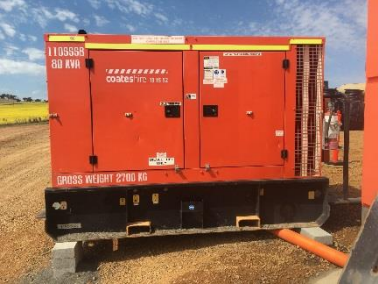
Chemicals and Fuels	<p>A diesel generator has been installed adjacent to the site buildings to power the site compound during construction of the project. RCR advised that the generator is self-bunded. A fire extinguisher is available at the generator.</p>

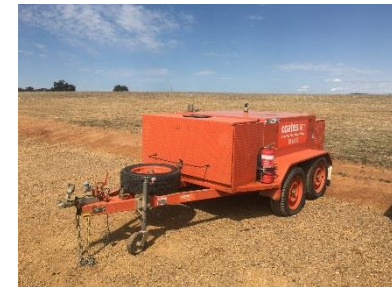
RCR maintain a refuelling trailer on site. RCR advised that the trailer is double banded and a spill kit is available in the trailer. RCR plan to set up designated refuelling locations across the project site however this is yet to happen. Refuelling is occurring on a gravel pad adjacent to the site buildings. A fuel register is maintained and was sighted at the inspection.

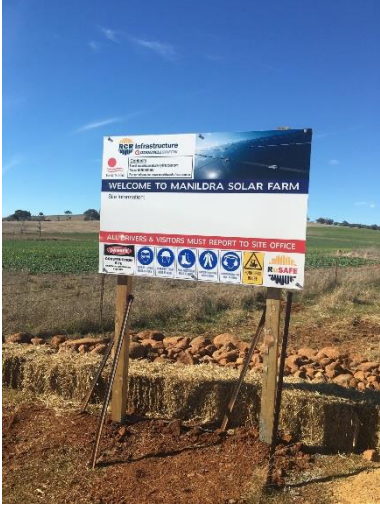
Issue	Observations & Corrective Actions	Due Date	Photographic Record
	Site has received some wet weather since pre-construction works commenced (30 mm over 3 days). The site has not received 20 mm in 24 hrs to trigger wet weather inspections and additional erosion and sediment controls.		
	While the construction site compound is being developed, site amenities are port-a-loos. SCECO advised that these are double skinned to provide protection against spills of raw sewage.		
Community Consultation	Community information day was held prior to commencement of construction. Details provided to community e.g. construction start dates to be reviewed at next ER inspection.		
Complaints	<p>Contact information is displayed on the sign at the entrance to the construction site.</p> <p>Manildra Solar Farm website has been updated with complaints contact details.</p> <p>No complaints have been received to date. A complaints register is yet to be established.</p>

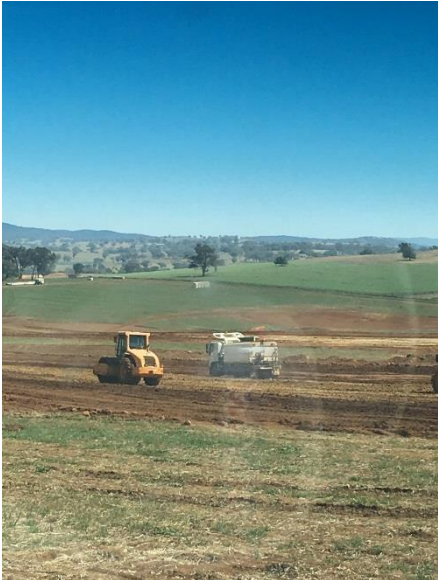
Issue	Observations & Corrective Actions	Due Date	Photographic Record
<i>Dust</i>	<p>At the time of the inspection, two water trucks were operating on site to manage dust for the works on Packham Drive and the earthworks on Arrays 7 and 8. There was minimal dust being generated as part of the works.</p> <p>Heavy vehicles were observed to be using designated temporary tracks.</p> <p>There were no deliveries to site during the site inspection.</p>

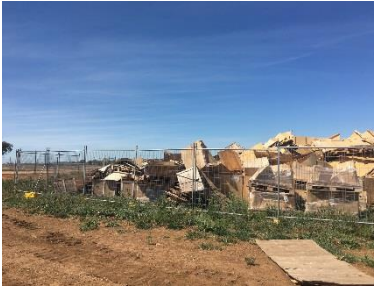
Waste	<p>RCR have determined, under their traffic management procedures, the waste contractor trucks do not need to undergo plant acceptance checks as they are not conducting work on site. This closes out CA 130917-01.</p> <p>Waste cardboard boxes and wooden pallets continue to be stockpiled on-site while reuse and recycling options are being finalised. RCR advised that a sample of the material has been taken offsite to test it for suitability to mulch. RCR should ensure MSM Milling's licence and/or approval allows for the receipt of waste materials from off-site.</p>

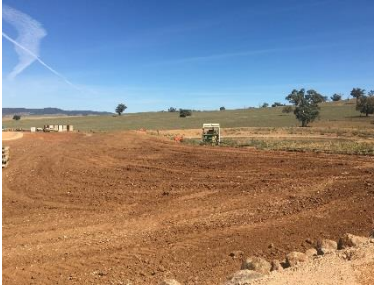
Issue	Observations & Corrective Actions	Due Date	Photographic Record
Noise	<p>RCR have purchased noise monitoring equipment and are developing a noise monitoring program to assess the risks for personnel on-site as well as the noise impacts for neighbouring sensitive receptors. Noise monitoring is proposed to be conducted at the school and nearest sensitive receptor during the week ending 26/01/2018, subject to weather conditions. Results from the monitoring will be provided to the ER for review.</p>		
Soil and Water	<p>RCR have been in discussions with Local Land Services (LLS) regarding rehabilitation of disturbed areas. LLS advised the existing program of re-seeding within seven days of handover from the earthworks contractor was not appropriate during the summer months.</p> <p>RCR are reviewing their erosion and sediment control measures for disturbed areas, particularly the main drainage line through the site and the on-site dam. Options being considered include geotextile in the main drainage line, seeding with millet (which can survive the hot and dry summer conditions) and rolling out round hay bales. For the areas under the solar modules, seeding will be conducted in autumn as per the Groundcover Management Plan.</p>

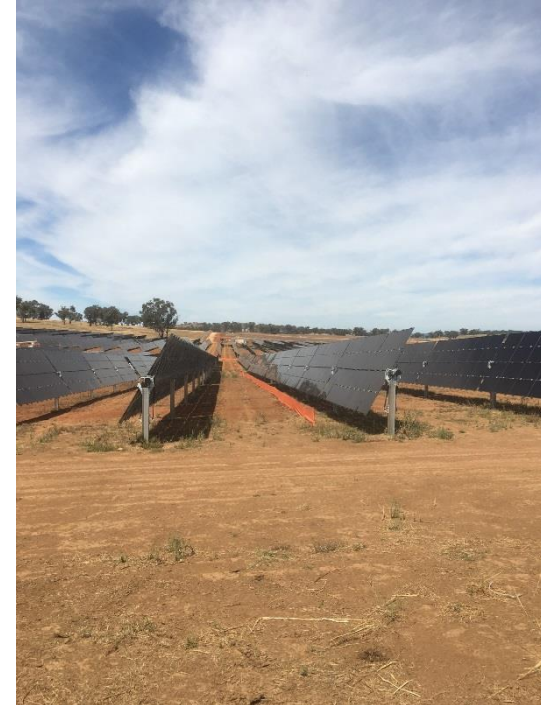
RCR advised that the bulk of the earthworks have been completed and Brefni are due to finish up at site this week. Brefni are completing the installation of rock check dams and rock stabilisation in identified areas across the site.

First Solar requested that additional rock be placed to stabilise the road on the eastern boundary where the natural drainage line flows onto site, and that, on completion of works, the access road to the

Issue	Observations & Corrective Actions	Due Date	Photographic Record
	<p>standpipe and farm dam be removed so as not to impede natural water flow.</p> <p>Topsoil spreading was underway during the inspection and was generating localised dust. RCR could consider options for pre-treating topsoil with a binding agent prior to spreading and establishing procedures that prohibit spreading of topsoil where wind conditions would exacerbate dust generation.</p> <p>Drilling, pile driving and traffic movements on site roads were all observed to be generating localised dust. RCR advised that two water trucks were still maintained however these were not observed to be operating during the inspection. No dust was not observed to be travelling over site boundaries or impacting on neighbours and no dust complaints have been received, however the CoA requires that there are no visible dust emissions from the project.</p> <p>Corrective Action 210218-02 – Implement all practicable dust mitigation measures to cease emission of visible dust generated by the project.</p> <p>Corrective Action 210218-03 – Place additional rock to stabilise the internal road on the north-east perimeter from water flowing onto site.</p> <p>Corrective Action 210218-04 – On completion of construction, remove the access road from the array to the farm dam so as not to impede natural water flow.</p>

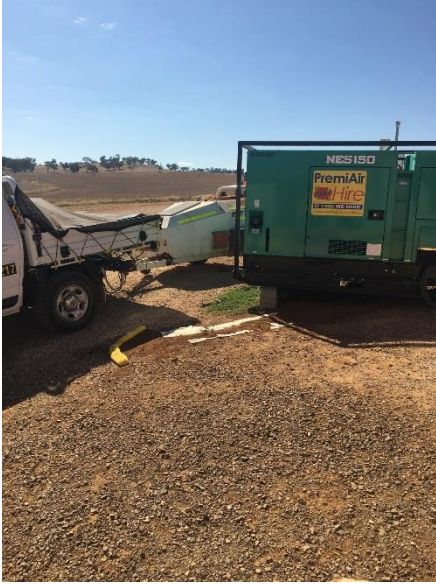
Issue	Observations & Corrective Actions	Due Date	Photographic Record
<i>Chemicals and Fuels</i>	<p>A small oil spill occurred at the onsite refuelling station / generator for the site offices on Monday 12 March.</p> <p>The spill was absorbed using the spill kit maintained at the refuelling station. An incident report was not available for review at the time of the ER Inspection. This is to be reviewed at the next ER Inspection in April.</p>

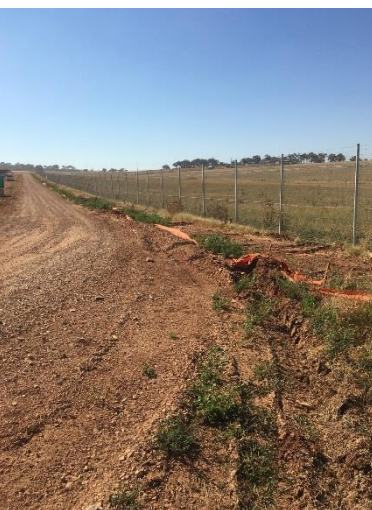
Issue	Observations & Corrective Actions	Due Date	Photographic Record
Soil and Water	<p>RCR provided photos and a site plan for the installation of rock check dams across the site prior to the ER Inspection.</p> <p>Additional hay bales have been purchased for the site to be placed behind rock check dams and to be used within the main drainage line to break up the slope length. RCR advised that these will be installed by the end of the week (16/03/2018).</p> <p>Once array installation is complete, hay will be spread in high risk areas to provide temporary groundcover. Identified areas include between the northern road and arrays 6, 7 and 8, along the north-south road and around arrays 3, 4 and 5.</p> <p>Rill erosion was still evident on the batter approaching the O&M building. RCR advised that they are currently seeking quotes from contractors to remediate the batter and stabilise it to prevent future erosion.</p> <p>A section of the sediment fence in the south-west corner of the site was observed to be down and required maintenance to ensure protection from offsite movement of sediment.</p> <p>Corrective Action 140318-03 – Conduct maintenance on sediment controls to ensure ongoing effectiveness.</p>	30/03/2018

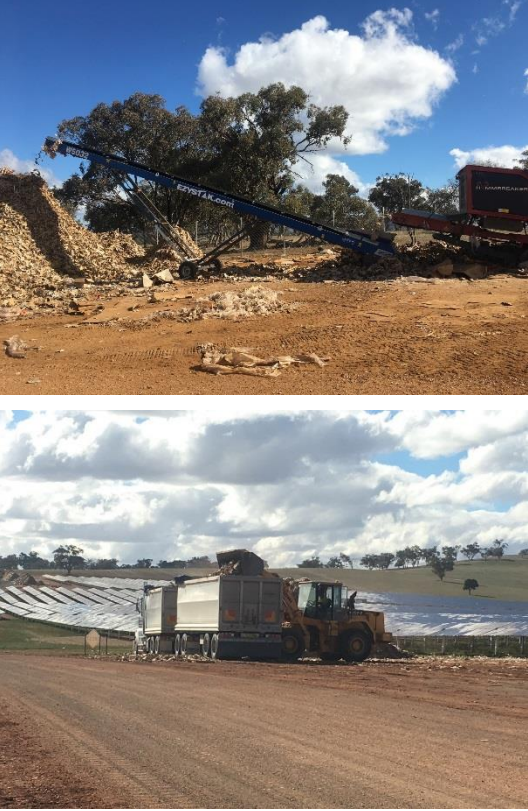
Issue	Observations & Corrective Actions	Due Date	Photographic Record
Waste	<p>Wind-blown litter from the mulched cardboard and pallets continued to be an issue on site and on the neighbour's property. RCR advised that the majority of litter was generated during loading of the mulched material onto trucks for transport to the Molong waste management facility. RCR advised that staff have been conducting daily pickups of plastic waste from the neighbour's property and across site.</p> <p>The mulching contractor and the waste transport contractor were on site at the time of the inspection (refer photos). One truck was observed leaving the site and the load was covered. RCR advised that all mulched material will be removed from site prior to the next inspection.</p> <p>Corrective Action 140618-01: Remove all litter from site and offsite before handover from RCR to First Solar.</p>

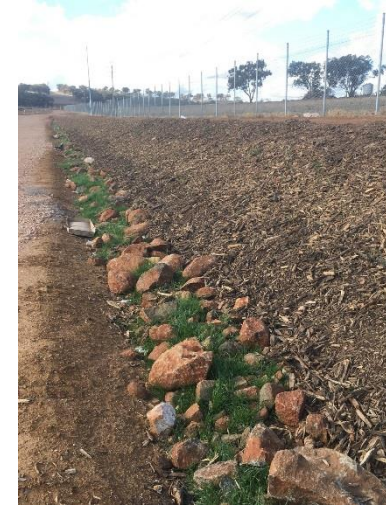
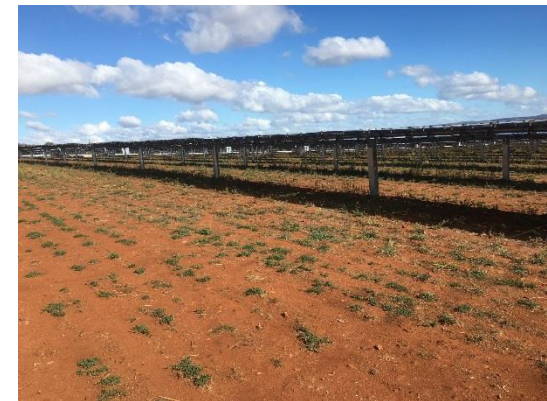
Germination across the site is very patchy as shown in the photos. Areas that weren't disturbed have a good cover of Lucerne, areas that were mulched with straw or woodchip show good signs of germination, weeds are establishing in some areas, some areas are yet to be seeded. RCR are still developing a plan for seeding the remaining areas of the site.

Corrective Action 140618-02: Reinstate sediment fencing along southern boundary of MSF prior to handover from RCR to First Solar.

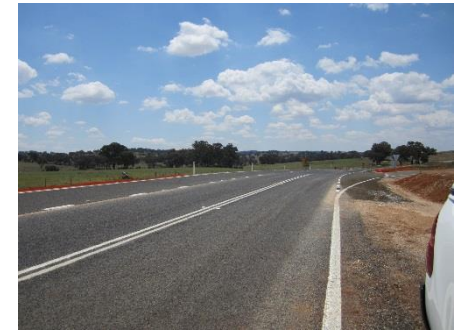
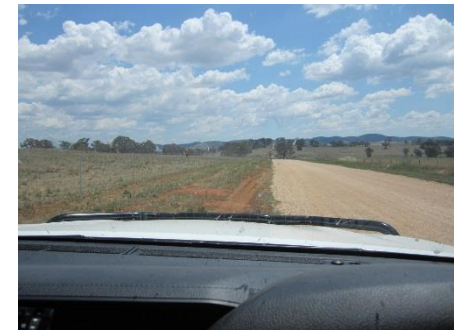
Site access control now includes boom gate.

Sides of the main access road were showing good growth following seeding.

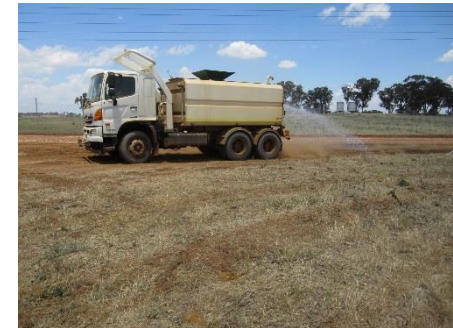
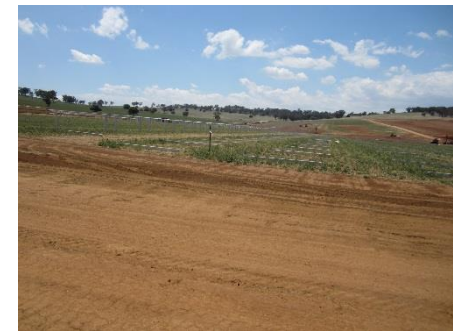
Disturbed areas of the site are being seeded within seven days of handover from the earthworks contractor, and watered to achieve groundcover targets.

Deliveries of gravel for the access roads across the site were occurring during the inspection. Loads were not contributing to dust generation.

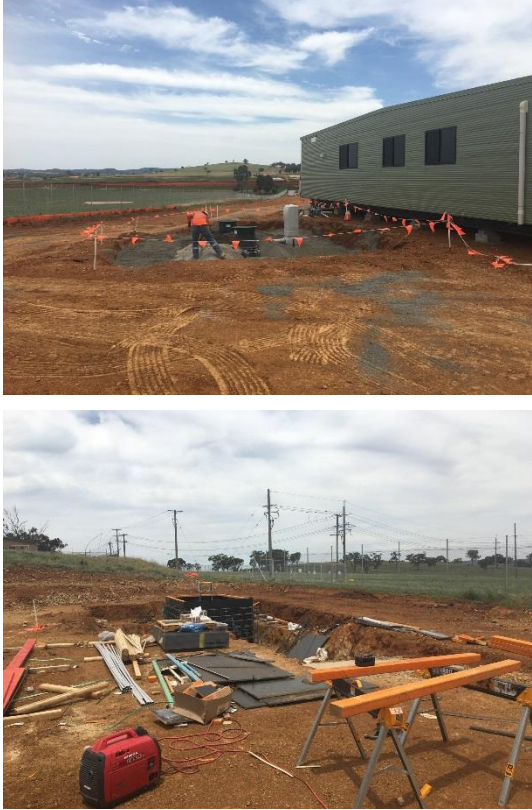
Issue	Observations & Corrective Actions	Due Date	Photographic Record
Site Compound	<p>Construction of the O&M building is underway including installation of the aerated wastewater treatment system (AWTS) and concrete pouring of the walls of the Photovoltaic Interconnection Switchgear (PVIS). Sediment fencing downslope of the disturbed area at this location requires some maintenance, as soil had been pushed up against the sediment fence during earthworks and a section of sediment fence had been removed.</p> <p>Sediment fencing in some other areas also require maintenance to reattach posts etc.</p> <p>RCR advised the sediment fence contractor was due on site 20/12/2017 to install some additional fencing before the Christmas period when they will be operating with limited staff.</p> <p>Corrective Action 191217 – 01: Conduct maintenance on sediment fencing.</p>	29/12/2017

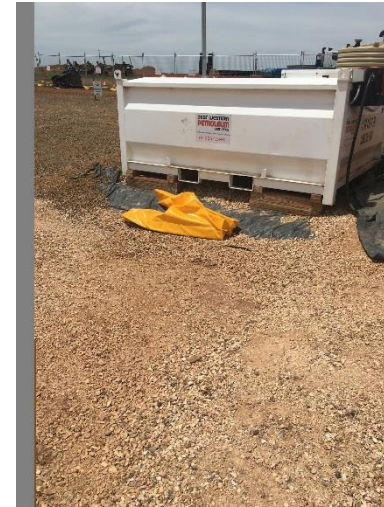
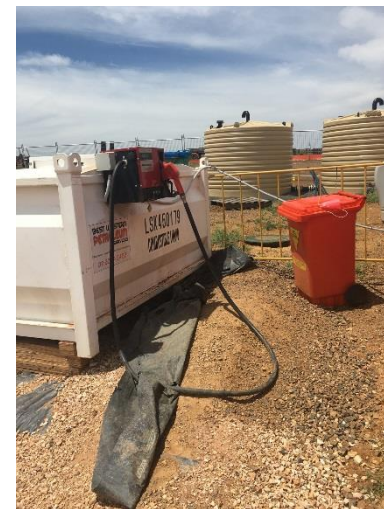
RCR have installed a double bunded permanent fuel tank adjacent to the main site offices. This refuelling station includes a plastic lined area for vehicles to park on during refuelling. The refuelling station is primarily used for refuelling ATVs. RCR advised two personnel have been trained for refuelling, however evidence to confirm this was not provided.
